## UPDATE GEOLOGIC HAZARDS STUDY SHADOW RUN RANCH PAUMA VALLEY, CALIFORNIA

URS Project No. 27665024.00002

September 29, 2009

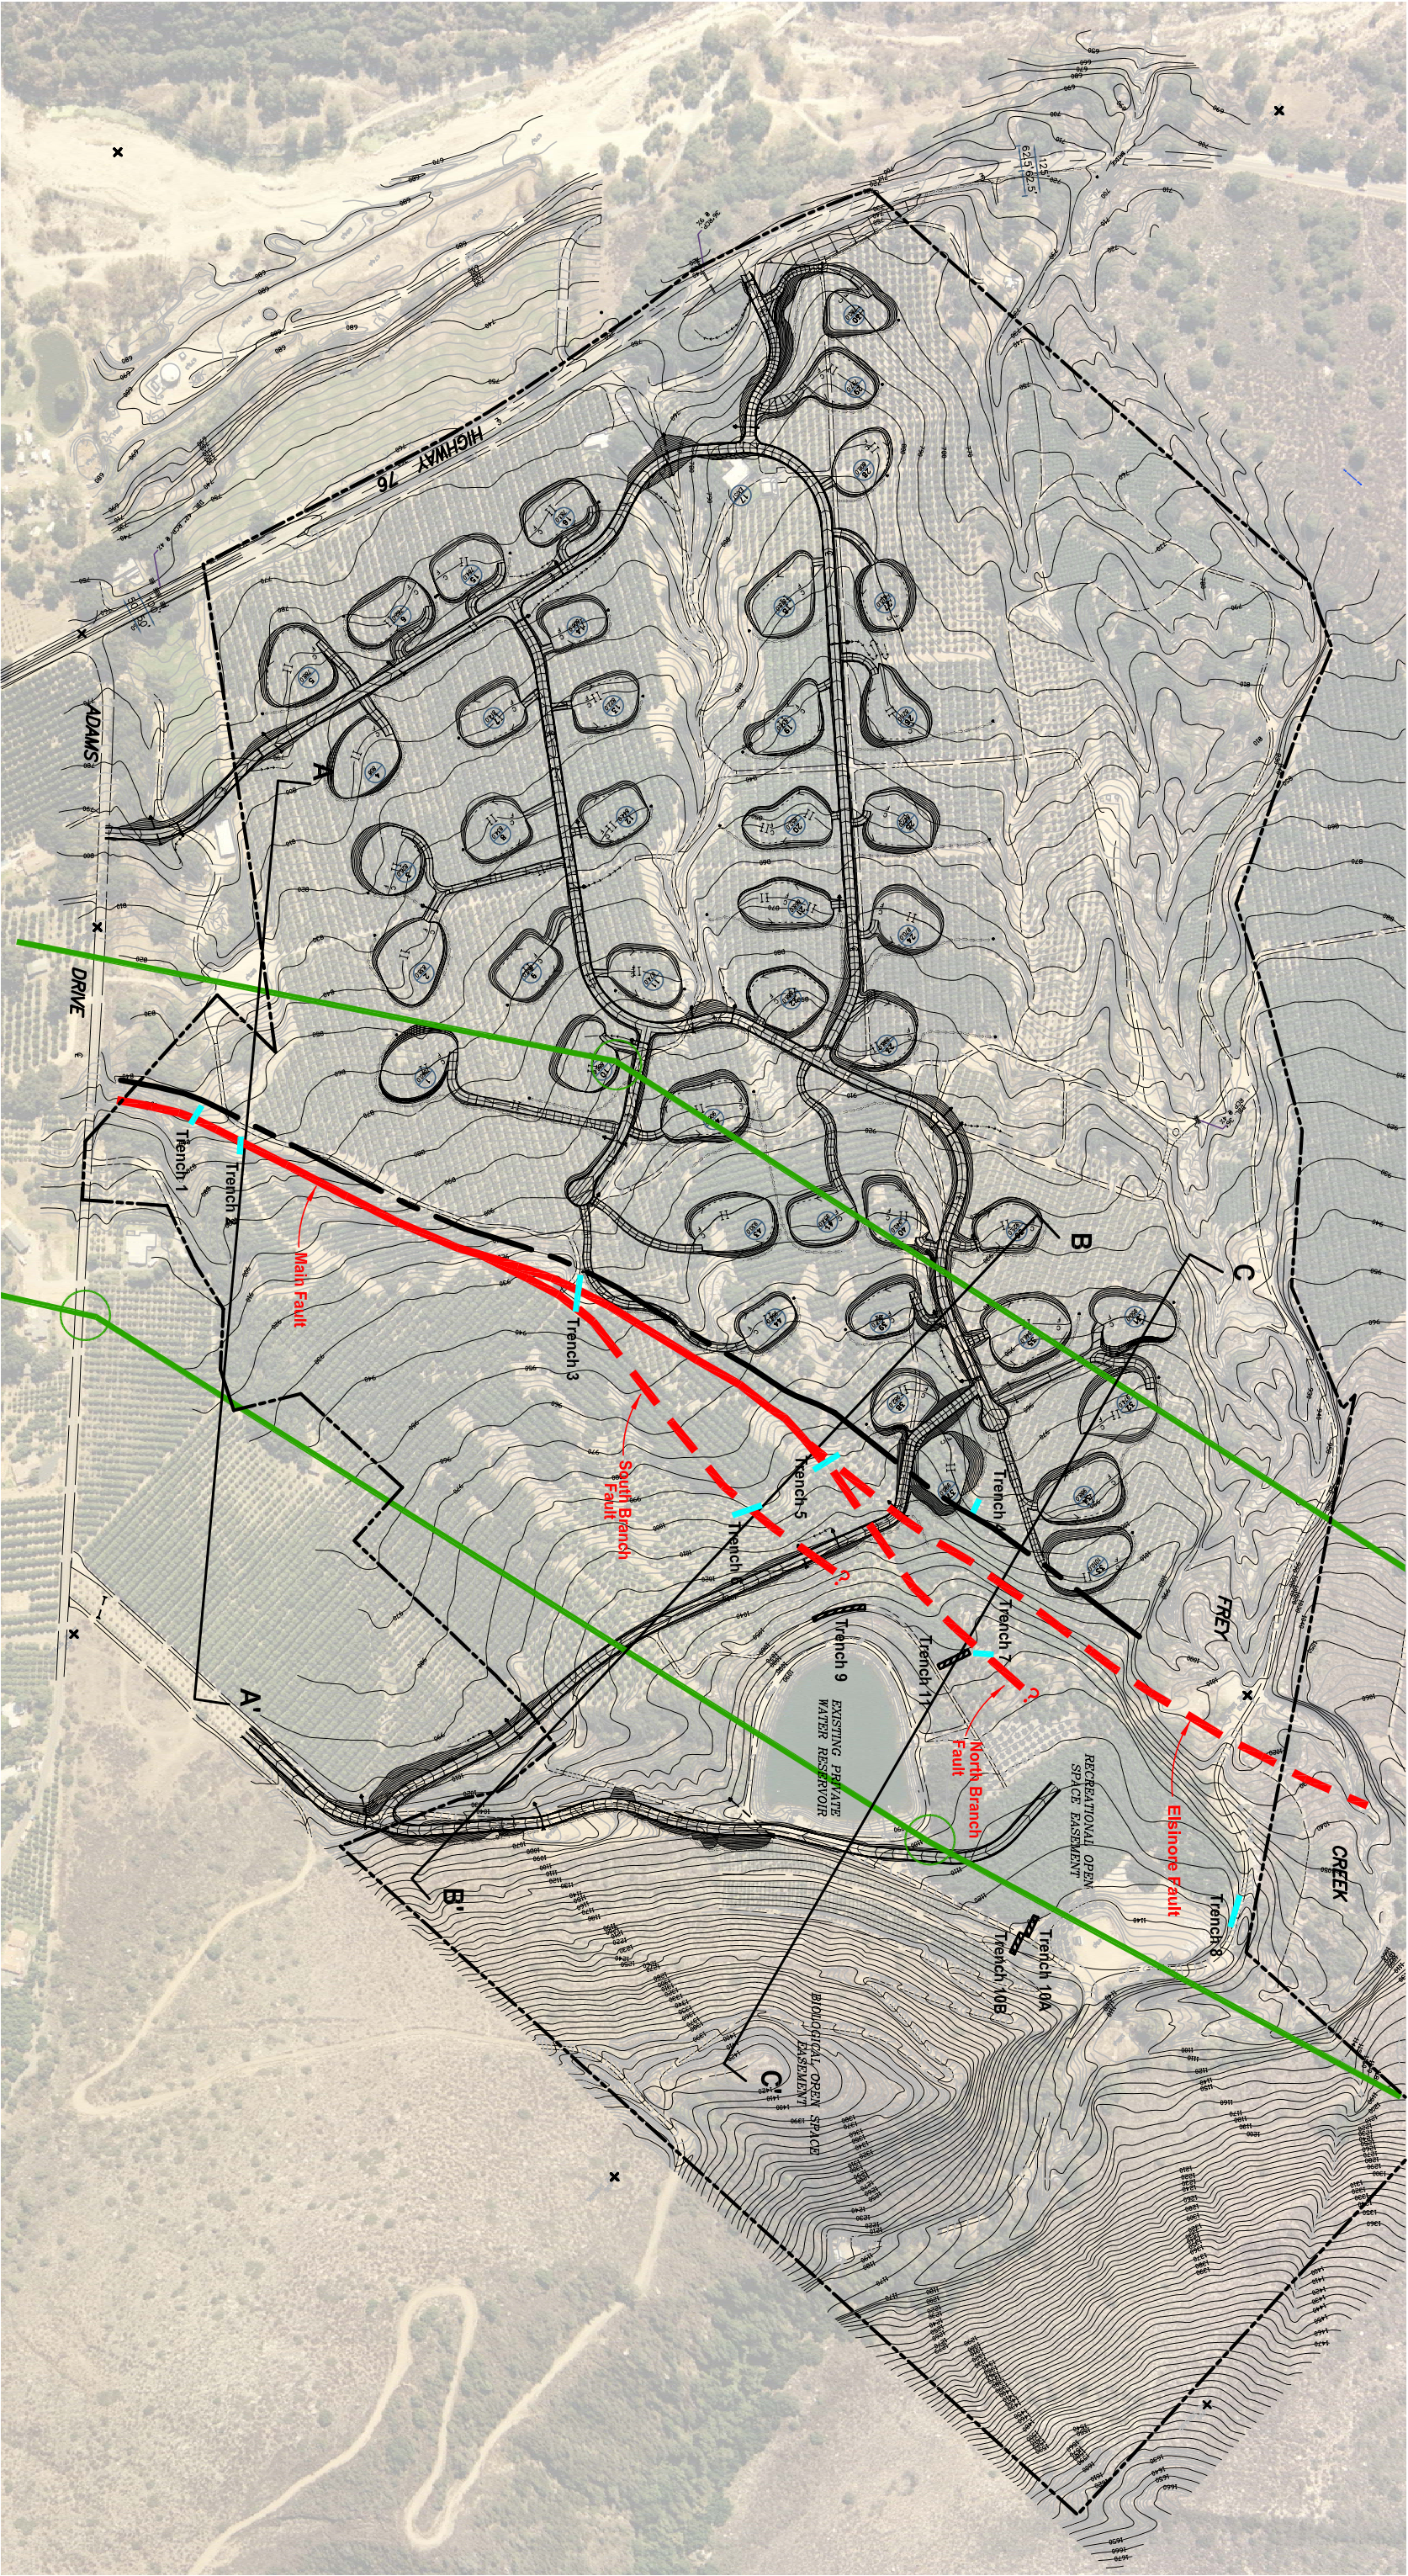
**FAULT MAP  
GEOLOGIC HAZARD STUDY  
SHADOW RUN RANCH**

The previous fault hazard investigation (URS 2001) mapped a through-going “Main Fault” as shown on Figure 8. The Main Fault represents the main surface trace of the Elsinore fault which on-site coincides with a pronounced, west-facing fault scarp, as revealed in the exploratory trenches excavated as part of the previous investigation. Fault set-backs for the proposed residential structures were recommended from the Main Fault, as shown on Figure 8.

No indications of faults were observed in Trenches 10A and 10B (see Figures A-3 and A-4). The trenches were excavated to depths up to 12 to 15 feet below ground surface into older alluvium and colluvium, which appeared to be pre-Holocene age. Based on these trenches, the hillside topographic slope break does not appear to be related to a fault. Accordingly, the suspected fault was removed from the updated fault map of the site (Figure 8).

The active Elsinore fault zone traverses the site and fault rupture is a significant hazard on site. The potential for surface faulting is considered to exist along all of the faults shown on Figure 8. The Main Fault and its branch faults exhibit evidence of Holocene activity and are considered to have the potential for future surface displacement.

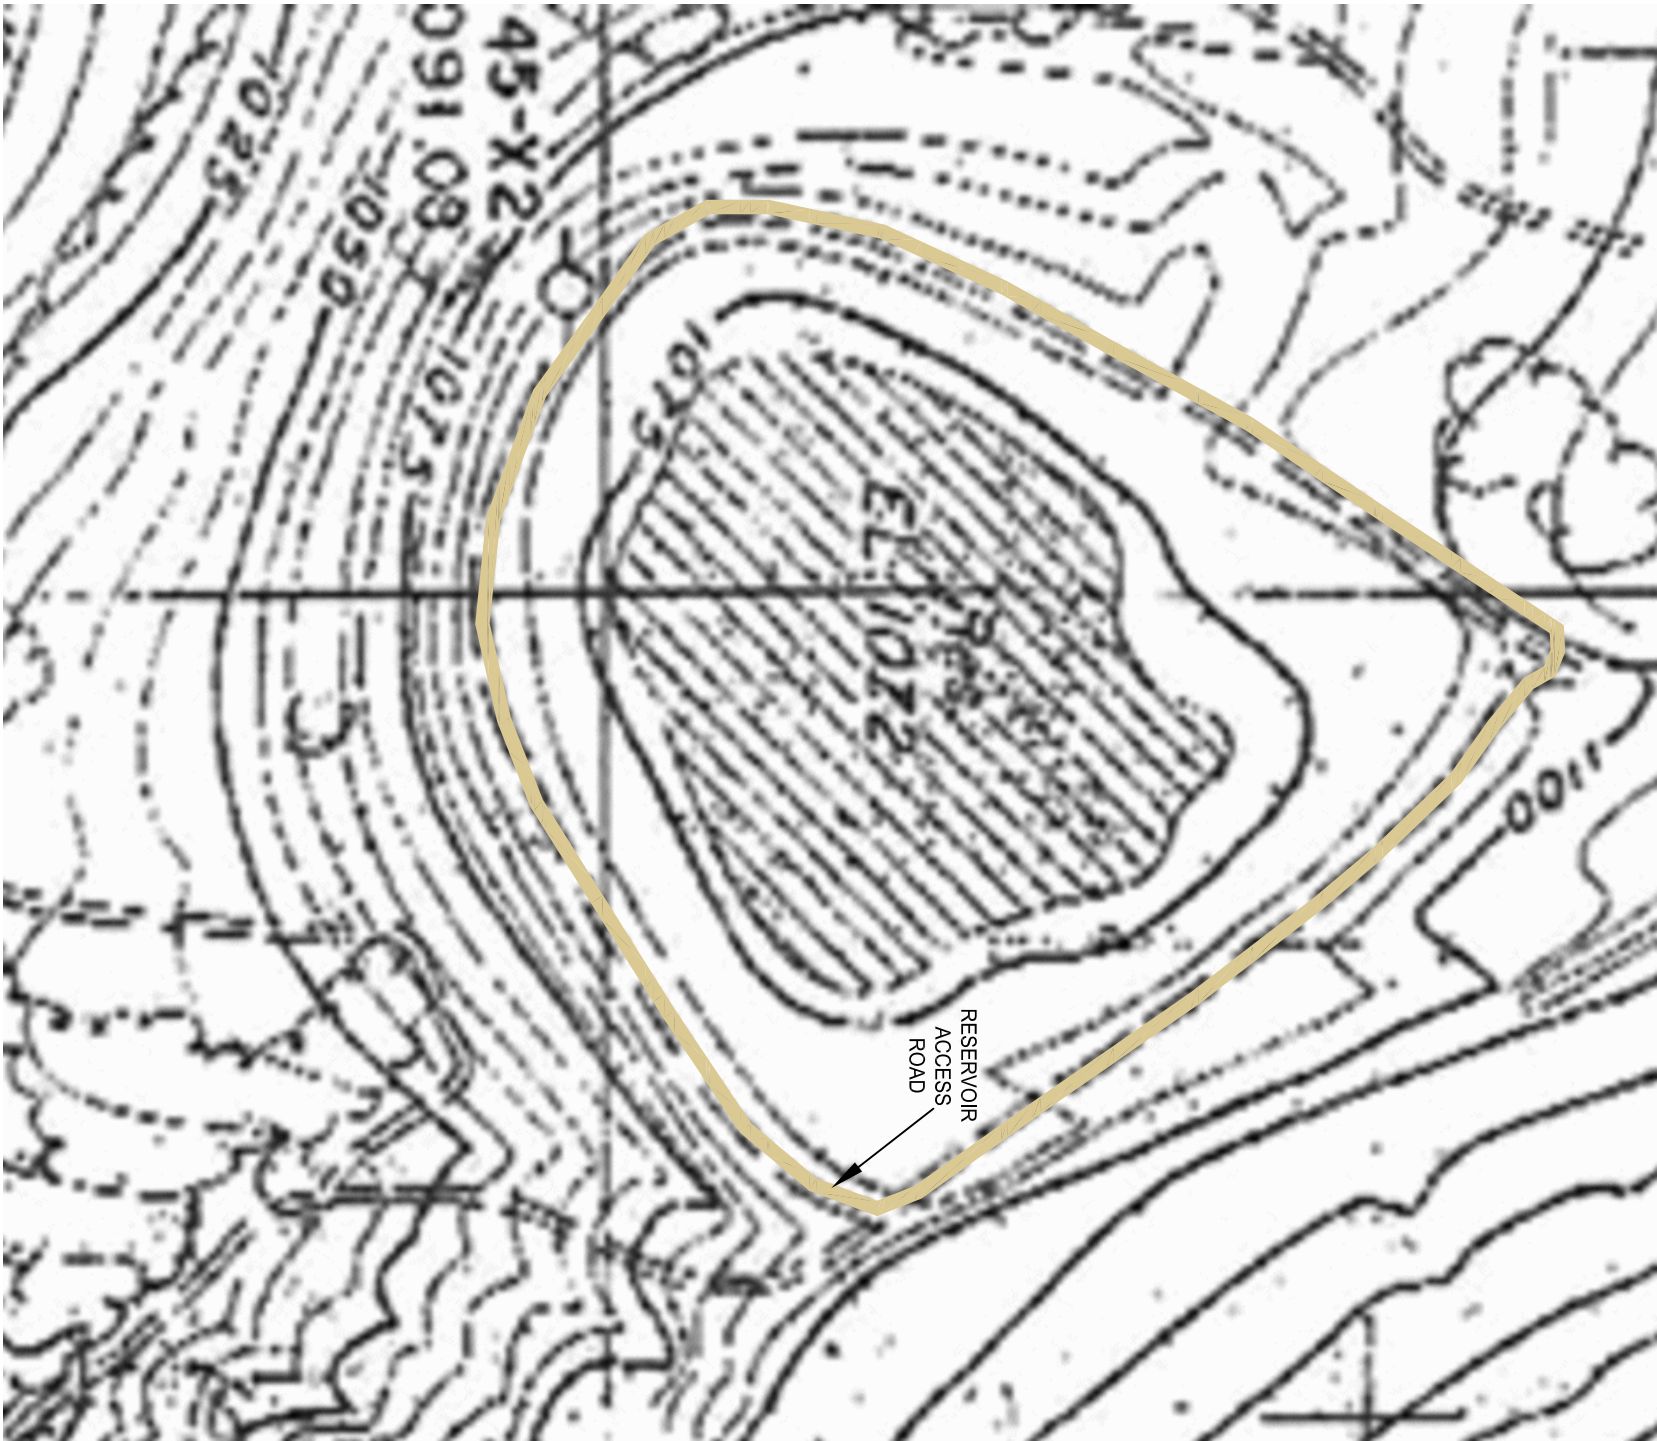
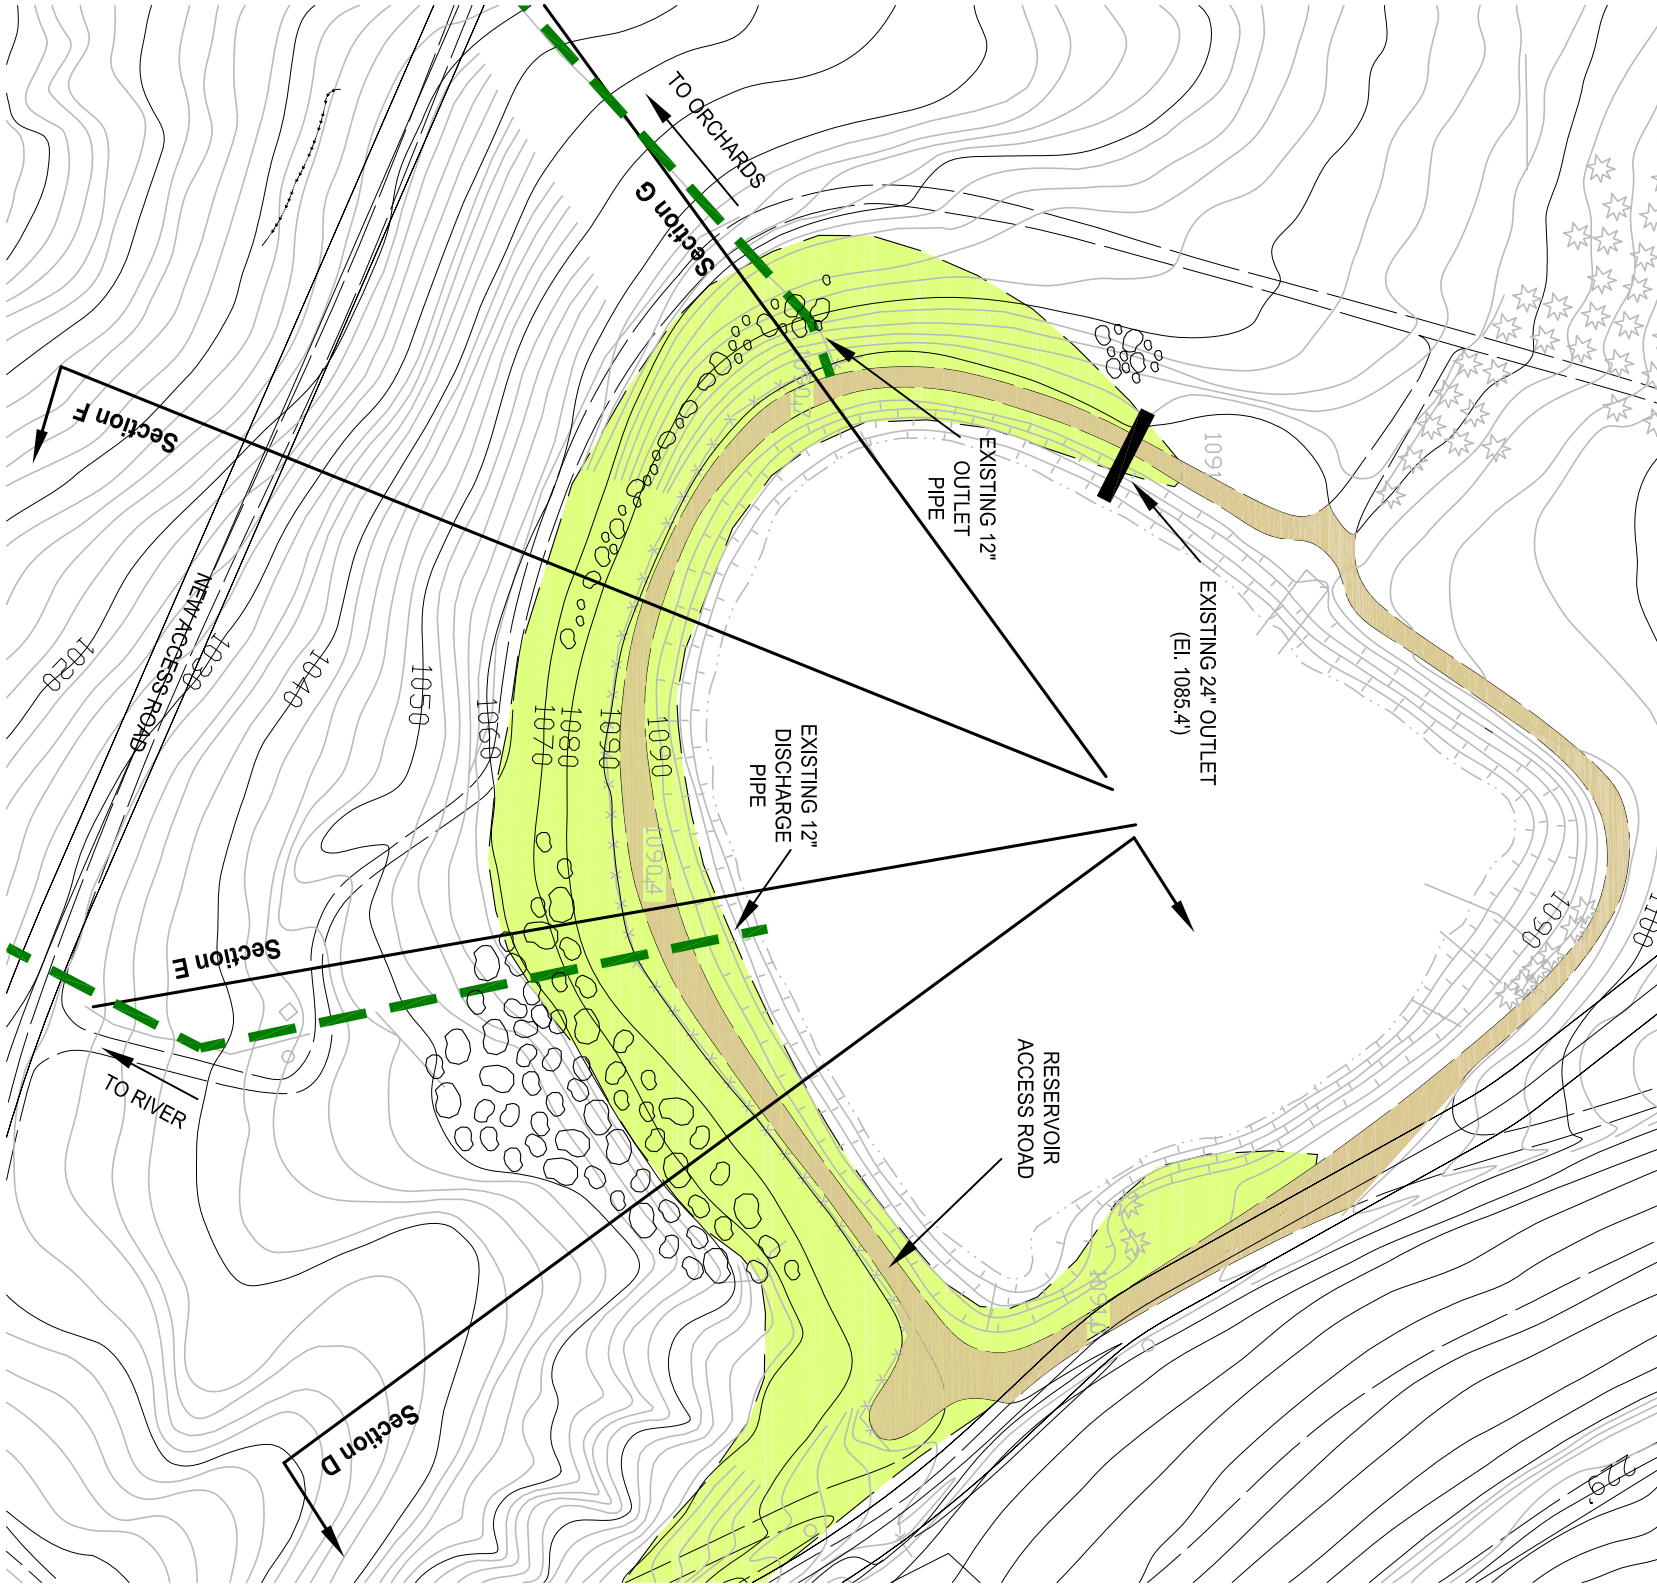
CHECKED BY:	DATE: 04-14-09	FIG. NO:
PM: DLS	PROJ. NO: 27665024.00003	9

A fill slope bounds the reservoir on its west and south sides, as shown approximately on Figure 9. Figure 10 shows generalized cross sections of this area based on the current site topographic map, estimated subsurface conditions based on site reconnaissance. The embankment fill slope is up to about 25 feet high (measured from the approximate water level to the fill slope toe) and has downstream slope inclinations between about 2.5:1 and 3:1 (Figure 10). The fill slope toe is along the top of stockpiled boulders in some areas.

No indications of groundwater seepage were observed along the slopes below the reservoir. Groundwater was not encountered in Trench 9, which was excavated just below the fill slope toe.

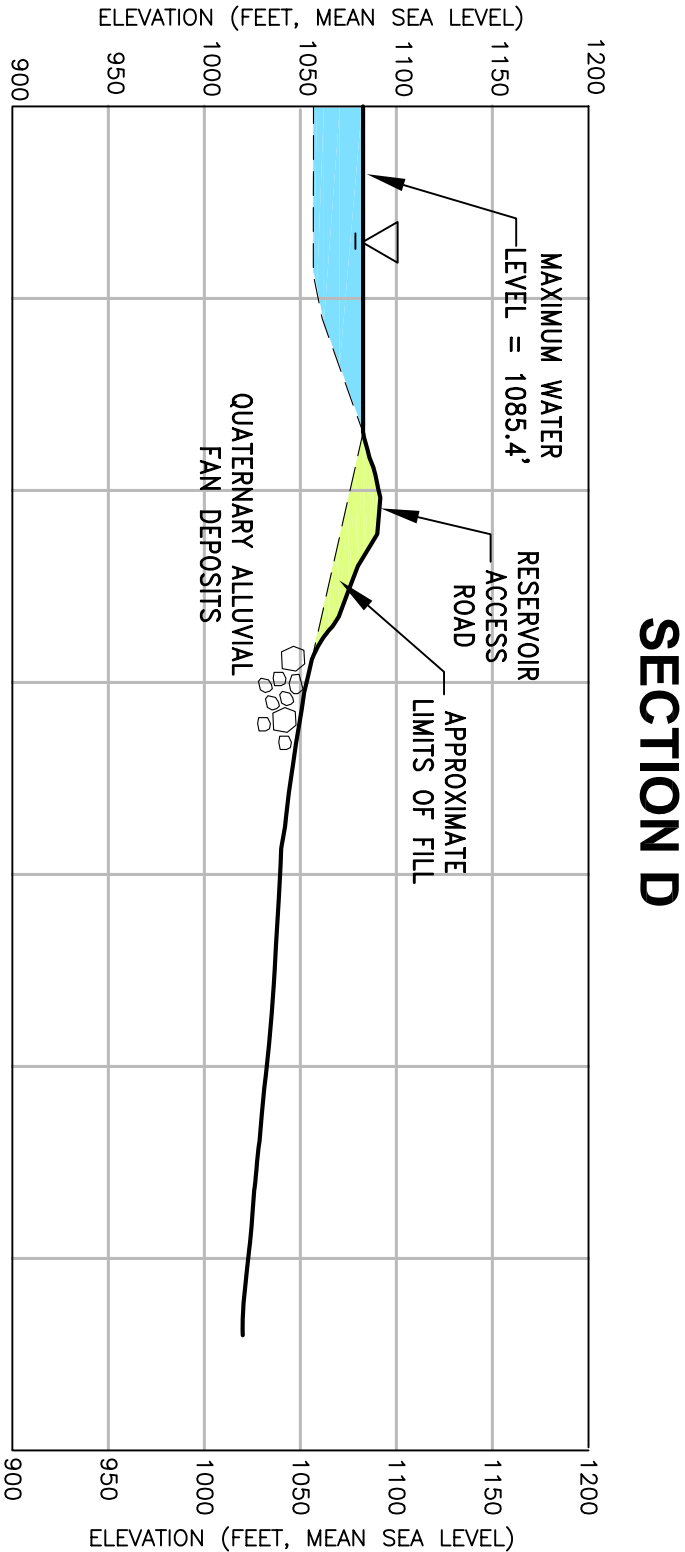
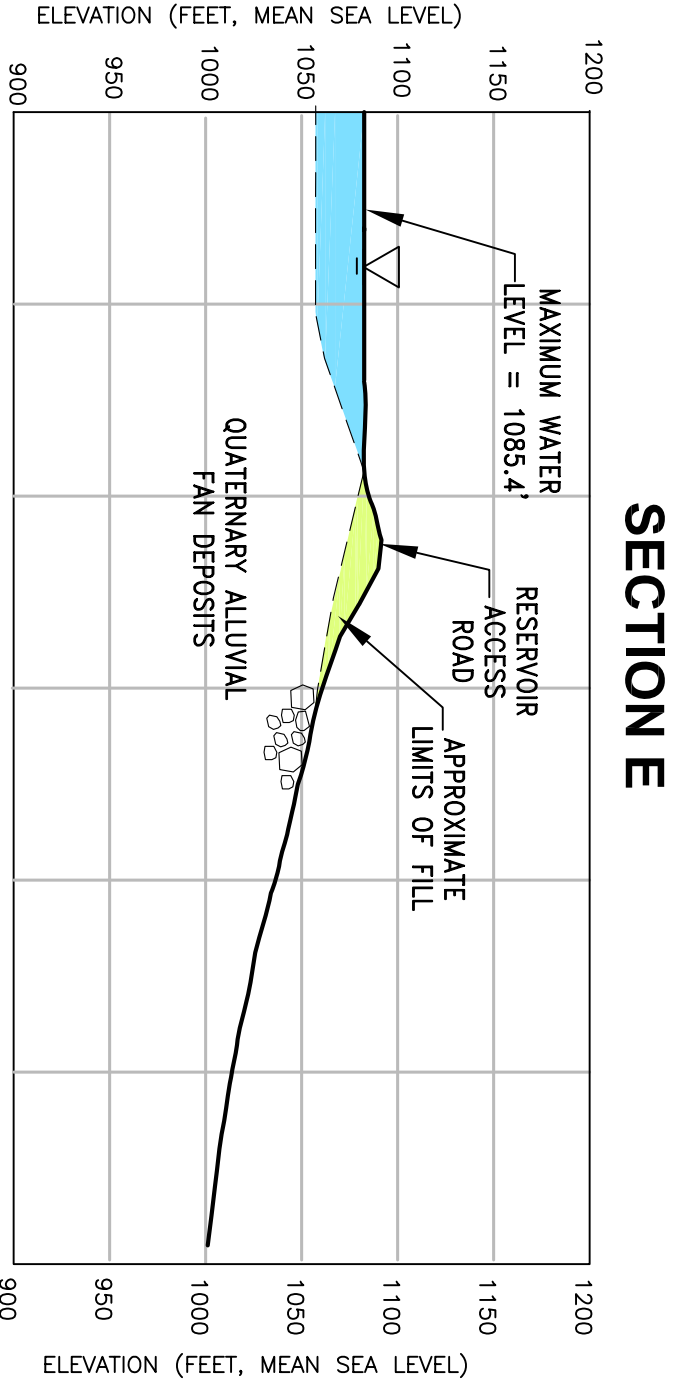
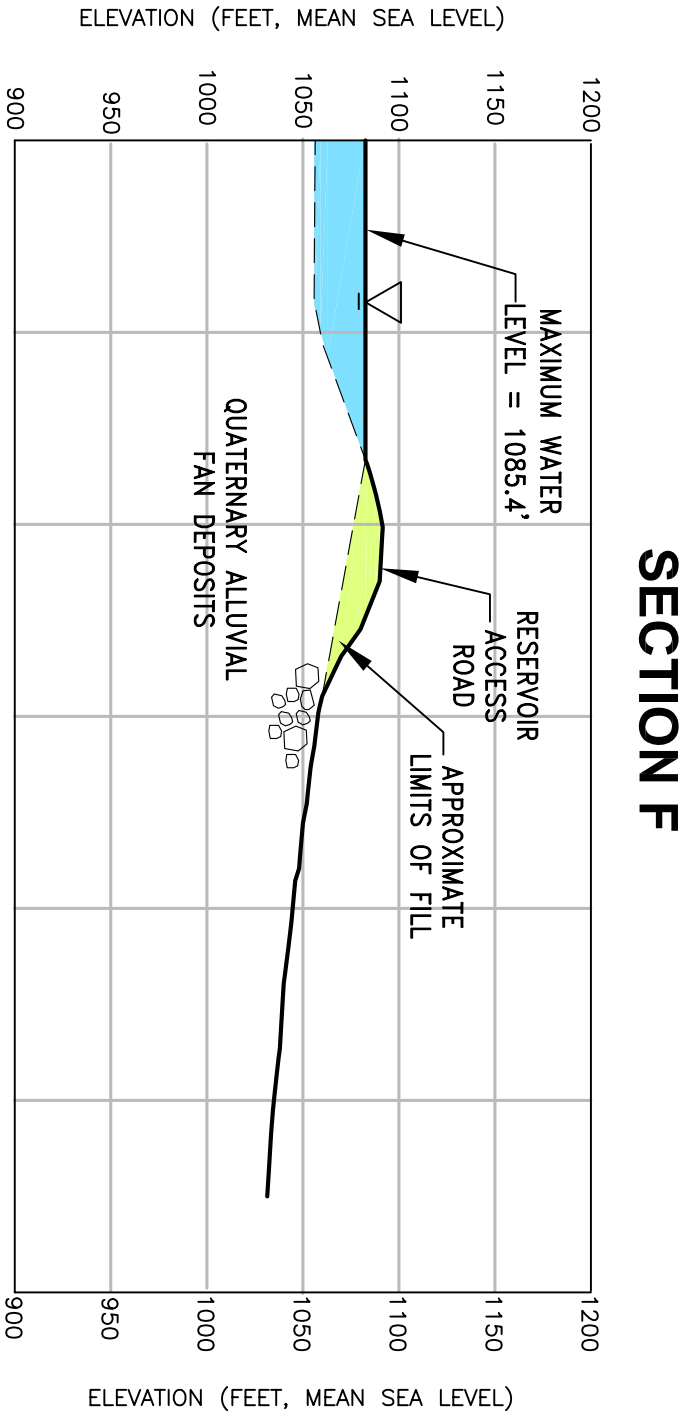
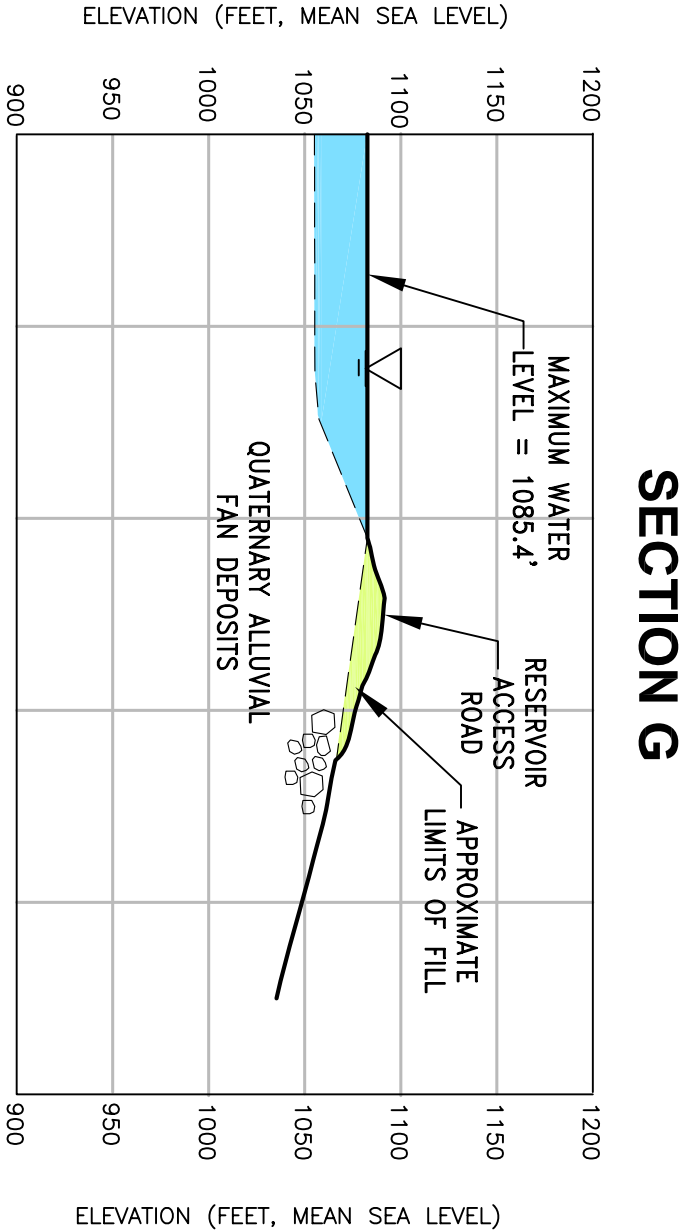
GENERALIZED CROSS SECTIONS D, E, F AND G

The existing reservoir embankment appears grossly stable based on preliminary evaluations of static and pseudostatic stability which include seismic coefficients. Following a seismic event, the water level within the reservoir could be lowered using the existing gravity pipelines to check the reservoir condition. Additional temporary drainage lines could be installed. No significant impacts are anticipated as a result of fill slope instability.

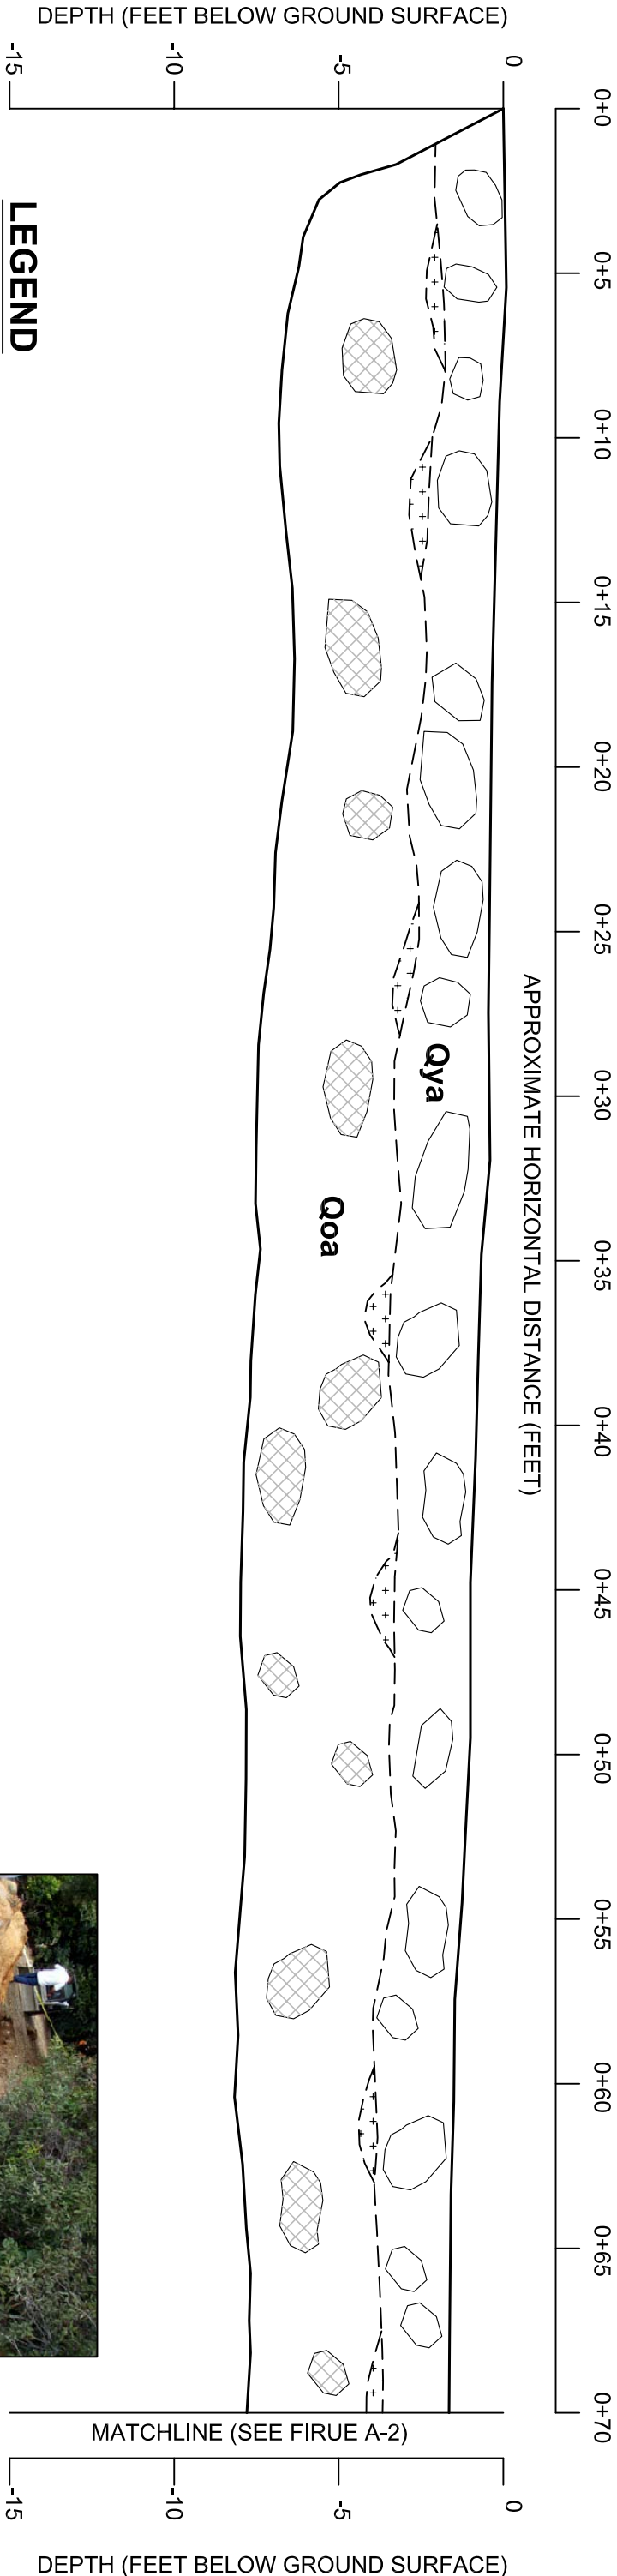
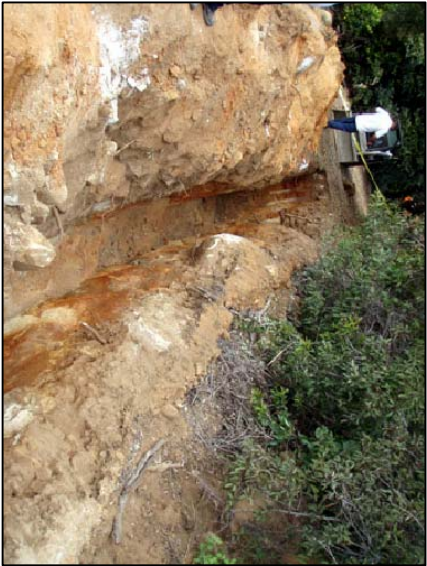
LOG OF TRENCH 9  
SHADOW RUN RANCH

No evidence of faulting was observed in Trench 9. The trench was about 140 feet long, and extended at depth into older alluvial fan deposits. Based on the completely weathered (decomposed) appearance of granitic cobbles and boulders, and the distinct reddish-brown color of the deposit (see Figures A-1 and A-2, Appendix A), the older alluvial deposits within the trench were judged to be pre-Holocene in age (i.e., older than about 10,000 years before present). The older alluvium within the trench appears to correlate with alluvial deposits at least Q5 or older, based on the previous geomorphic assessment of Pauma Valley (Vaugh 1987).

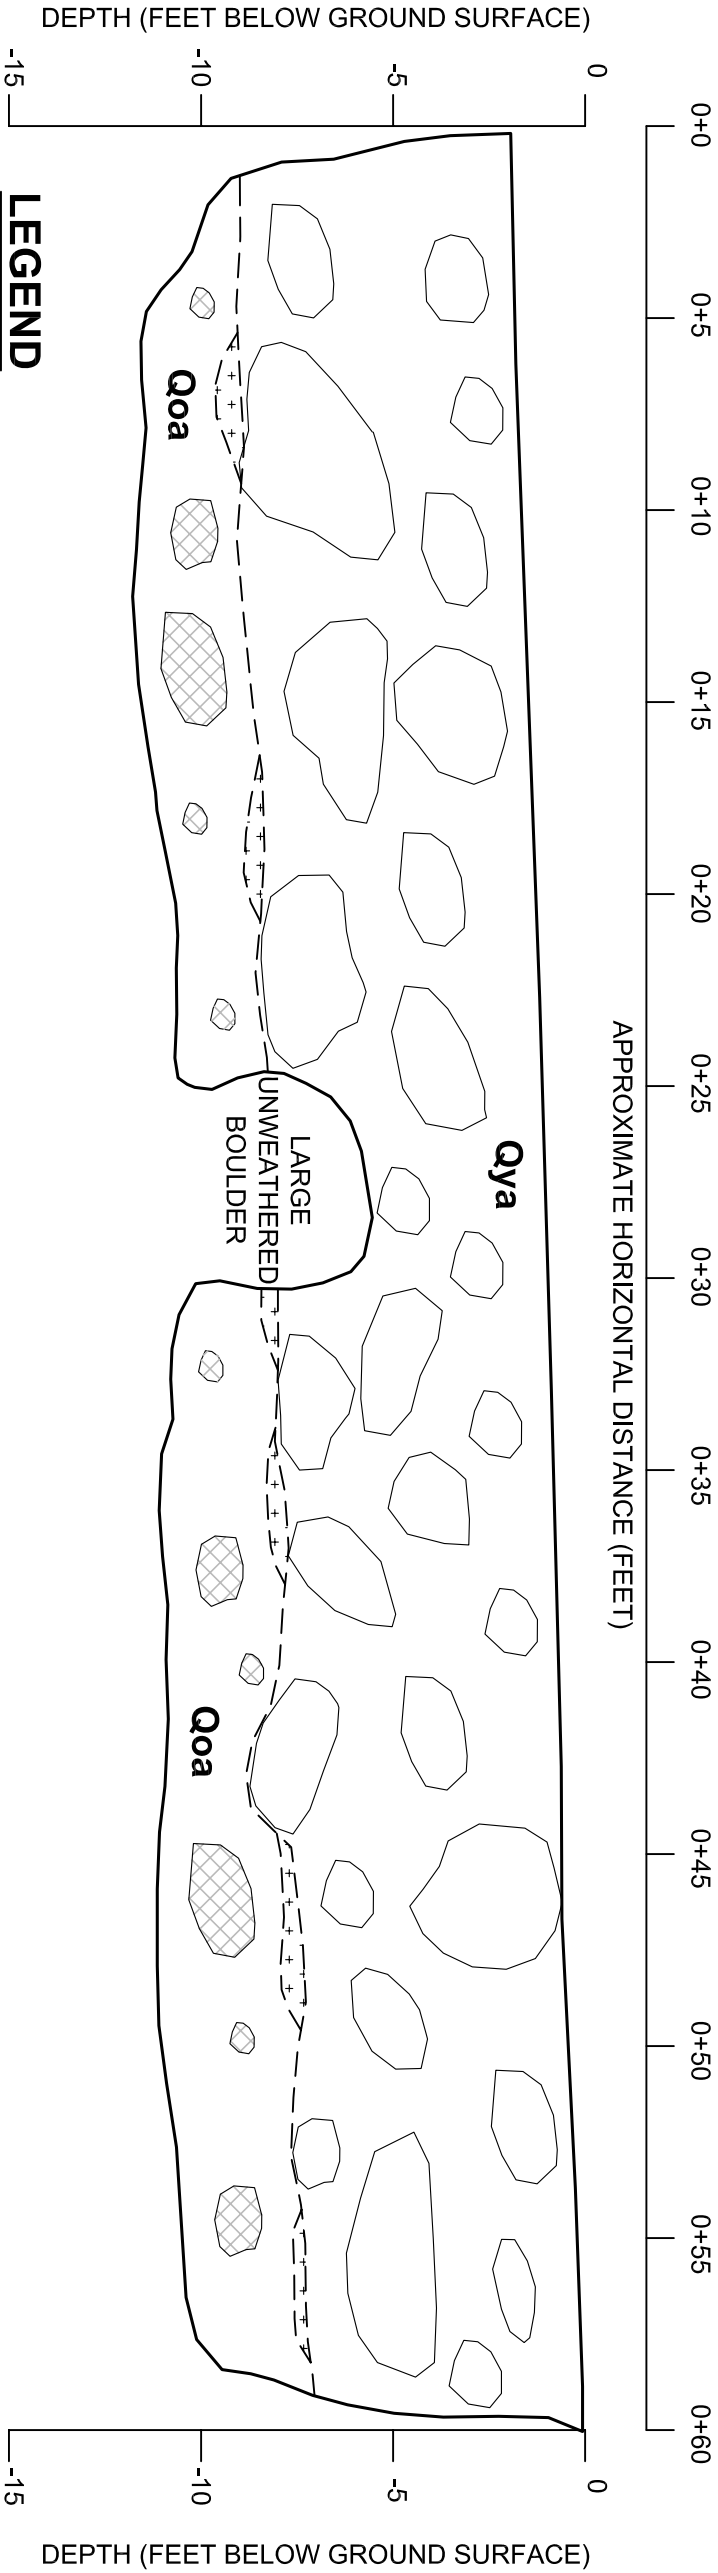
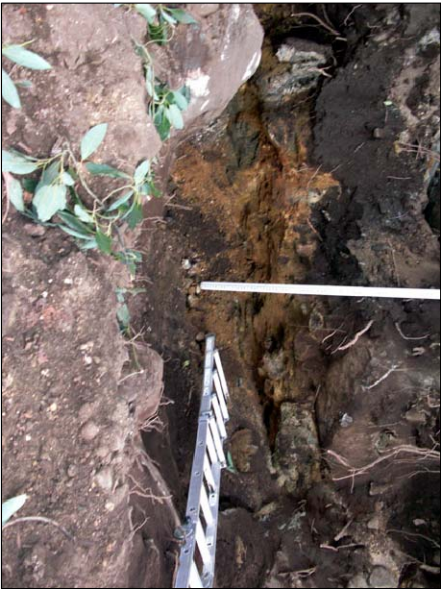
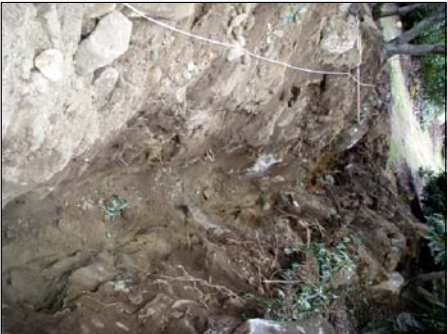
LOG OF TRENCH 11  
SHADOW RUN RANCH

No evidence of faulting was observed in Trench 11(see Figure A-5). The location of Trench 11 was selected to further verify the absence of faults near the reservoir. The absence of faulting in Trenches 9 and 11 indicates the South Branch Fault appears to bend westerly and does not underlie the reservoir, as shown on Figure 8. Linear topographic features also suggest the slightly more westerly fault location.
